Watershed Agricultural Program 2011 Annual Report and 2012 Workload

**for the New York City Catskill/Delaware and Croton Watersheds
February 2012**

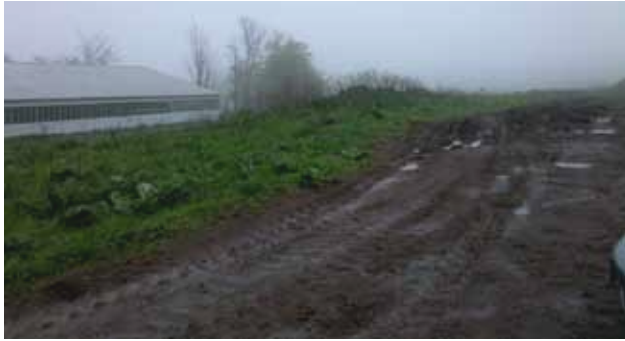
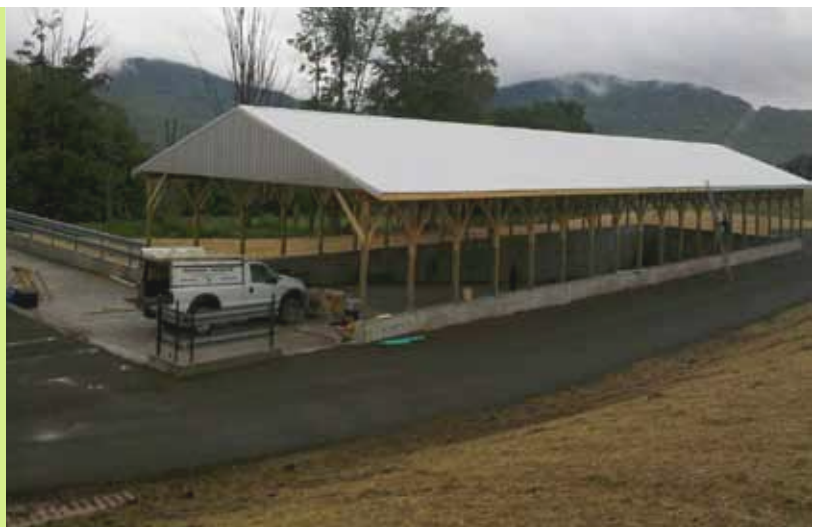
Stamford, Delaware County Covered Manure Storage & Access Road

TOP: This muddy area, just right of the existing daibarn, set the stage for a future access road leading to a covered manure storage unit. At the farmer's request, the team planned new construction catty-corner from the barn's rear right corner.

BOTTOM: This 40'x150' covered manure storage unit is one of the largest built by the Program. Compare the man on the ladder and truck to the structure. At its deepest point, the manure bay is 10 feet down; the roof is 12 feet high at the truss header. One-inch-minus gravel lines the laneway. An underground drain alongside the exterior concrete wall funnels roof runoff behind manure storage unit. This project infused over \$200,000 into the local economy through job creation and materials purchases.

In May 2011, the Watershed Agricultural Program began construction on a 40'x150' covered manure storage, one of the largest built to date in the region. The structure addressed water quality issues of manure quantity, storage capacity and potential phosphorus load that impacted the nearby Cannonsville Reservoir. Located at Eklund Farm--a 400-cow organic dairy farm on 2,700 acres in the Town of Stamford, Delaware County--the project addressed water quality issues in a sensitive basin while providing an outdoor storage for

To remedy the stockpiling of manure inside the barn, the team originally proposed locating the manure storage directly behind the dairy barn. However, the landowner preferred the storage unit be built to the back-right of the existing barn. "We installed a scrape pad and alley to improve efficiency of clean up and collection to the outdoor storage area," explains Pete Steenland, P.E., Engineering Specialist for the Watershed Agricultural Council. "The farmer uses a tractor to clear manure out of the barn and on top the scrape pad. From the scrape pad, the farmer continues pushing the load down a graded ramp, known as the scrape alley. The ramp from the access road leads right into the manure structure. The concrete is sloped and grooved to direct manure and fluids directly into the covered storage area. We built a new access road with a solar powered electric fence that helps the farmer access the barn, animals and covered unit. This work also improved drainage in, around and behind the structure."

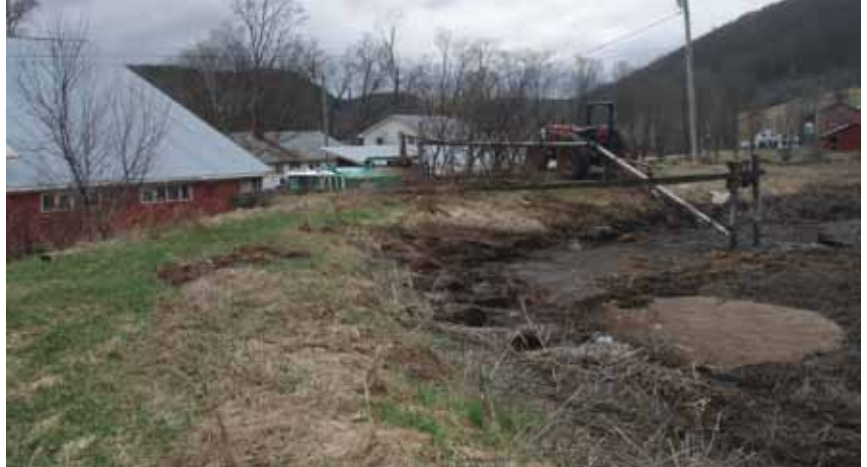
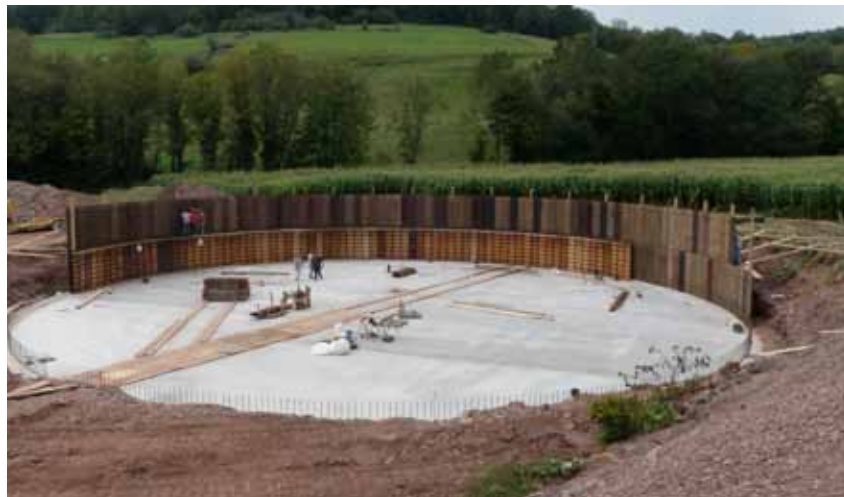
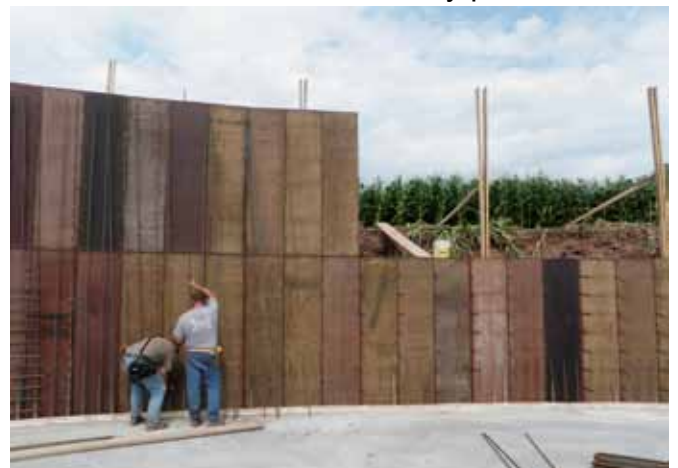
Delhi, Delaware County Manure Storage AWEP Funding

The Clark Farm milks 130 Holsteins and is located on Elk Creek Road in the town of Delhi NY, in the Cannonsville Watershed. The project's goal was to eliminate two earthen manure lagoons: one at the main milking facility and one at the heifer facility. Both lagoons had water infiltration issues;

the new storages allow the producer to follow the farm's nutrient management plan to help limit the run-off possibilities. Three challenges arose at the project site. First, the project site was divided by Dry Brook. Second, the distance separating the two barns made it cost-prohibitive to install one storage used by both facilities. Third, a high water table, due to the proximity to Dry Brook, posed fluctuating water variables. The Planning Team recommended constructing two cast-in-place, in-ground

concrete storages. The main barn storage is 120 feet across in diameter and 16 feet deep, capable of storing 1.3 million gallons. The heifer barn storage is 60 feet across by 16 feet deep and can hold 338,000 gallons. The project also required a new manure pump system to handle the manure at the main barn. The Team accomplished this by changing an existing gutter-style barn cleaner to a gravity-gutter that feeds the new hydraulic-style piston pump that pumps to the 120-foot storage. A stand-alone pump building was set up so the pump could

be in a central location for the gravity gutter, and not interfere with current farm access. The milkhouse waste along with the parlor waste is now pumped to storage. Manure at the heifer facility is now scraped directly into the 60-foot storage which is located off the end of the barn. A newly purchased

lagoon-style agitation pump facilitates agitation and manure removal from the new storage tanks. Once the new storage tanks were constructed and operational, the old earthen lagoons were decommissioned. The heifer facility lagoon was decommissioned by having the dams removed and leveled out to match existing ground. The main barn lagoon was decommissioned using a combination of dam removal and fill dirt to match grades around the former lagoon site. LaFever Excavation was the General contractor for the project and sub-contracted Ben Reynolds Construction for the concrete work. The project cost \$598,288.

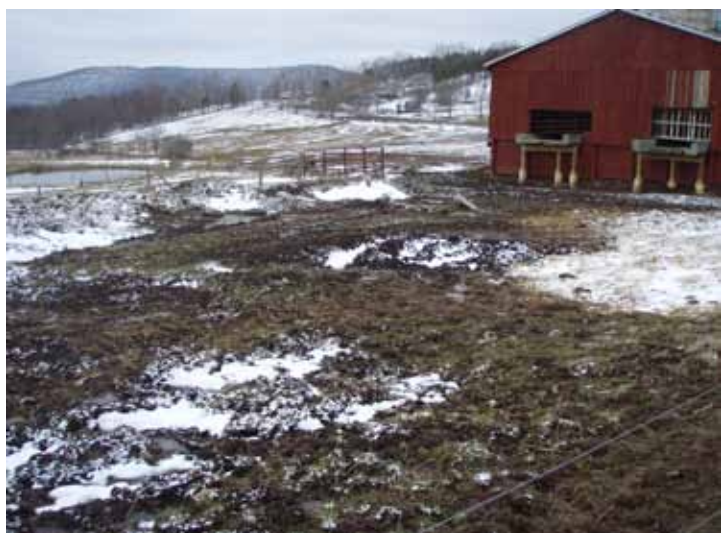
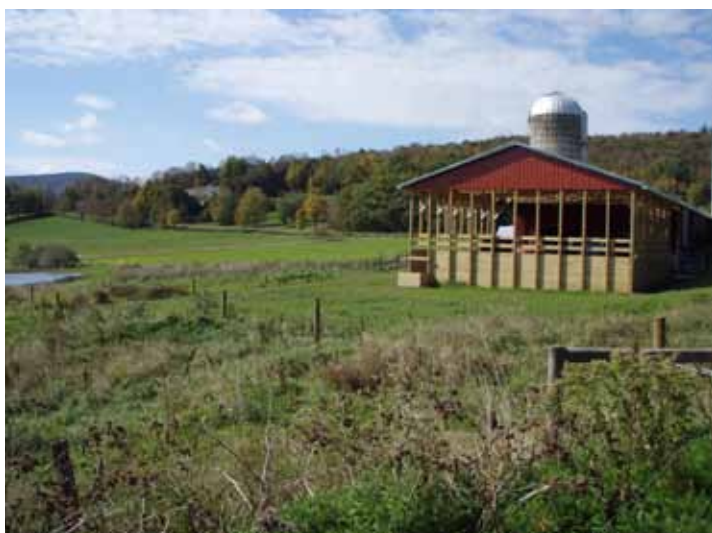
Stamford, Delaware County Covered Barnyard, Access Road Animal Walkway, Watering

At this 140-acre beef farm in Stamford, Delaware County, farmer John Trovato raises 30 cows, grows garlic and tends bees. During the spring and summer, the herd grazes on pasture according to a rotational grazing plan created by WAC Small Farms Coordinator Dan Flaherty. In winter, the farmer brings the herd closer to the barn which posed a feeding area problem. The water quality issue was simple: address the winter feeding area adjacent to stream just eight feet away.

Many water seeps and drainage issues around the barn had to be addressed during the first part of construction. Those identified were laid with cobbles; buried perforated pipes directed drainage into the Conservation Reserve Enhancement Program (CREP) area. An underground drip trench lined with PVC pipe and gravel also surrounded the barnyard to allow roof water to flow into the CREP area behind the barn. The Plan called for a CREP riparian forest buffer. Last year, roughly eight acres and necessary fencing were installed to keep animals out of the stream. This year, additional fencing connected with the CREP fencing, thus protecting a hydrologically sensitive area.

Construction was neat and simple. Sun-sky panels dotted the tin roof. Laminated poles, comprised of three-treated-then-glued-together 2x6s, supported the 40-foot by 60-foot structure. These new laminated poles offer better strength and protection from rot than standard 6x6 posts. Built off the existing barn, the new construction allowed farmer access to two existing manure push-offs that he wanted to utilize. “The water trough tapped into an existing spring development we installed in 2010,” added Flaherty. “The gravity-fed, continuous flow set-up provided year-round watering to the feeding/manure storage area.” As part of the overall Whole Farm Plan, the Council also purchased a bucket loader for the farmer’s tractor to help with barnyard clean-up. “Thanks to the farmer and his farm manager, we trouble-shooted the issues and breezed through this project in record time,” added Flaherty.

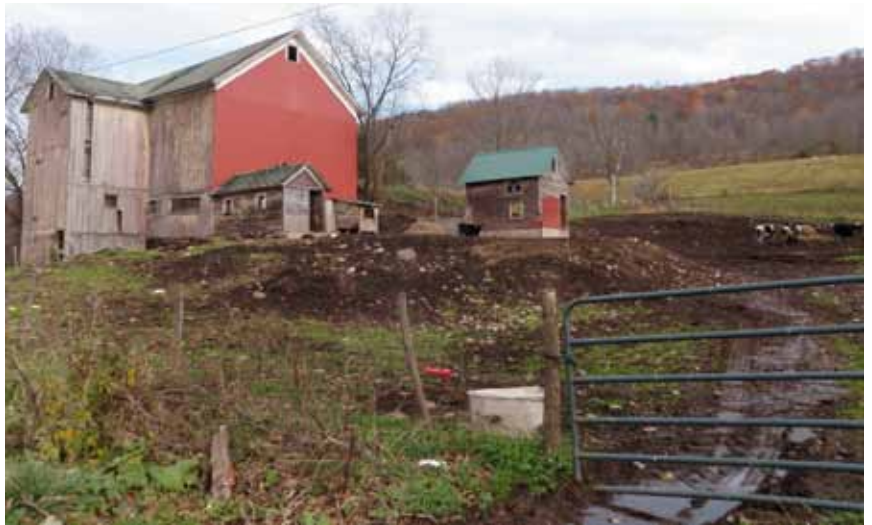
TOP: Youngstock area with drainage issues

The youngstock building accommodates two different aged animals. Through a gated system, the farmer can corral older heifers in the open, covered feeding area and gate off younger animals in a separate, safer area. Normally, the farmer used an I-beam feeding trough along the outside of the building. The new structure, with feed dispersed down the center, allows the two groups to be separate but eat from the same pile. This center feed alley posed a new challenge for the farmer to relearn how to navigate the Bobcat in order to clear away the feed area. “By making the feed area wide enough for a skid steer turning radius, we now have an issue for the cow reaching out for feed, something we’ll troubleshoot going forward” added O’Brien. Two watering facilities, one on each side for the separated animals, provide water from an original gravity system installed 8 years prior. “With no electricity out to the heifer barnyard, we chose continuous overflow, gravity system as we had no ability to heat the water,” added O’Brien.

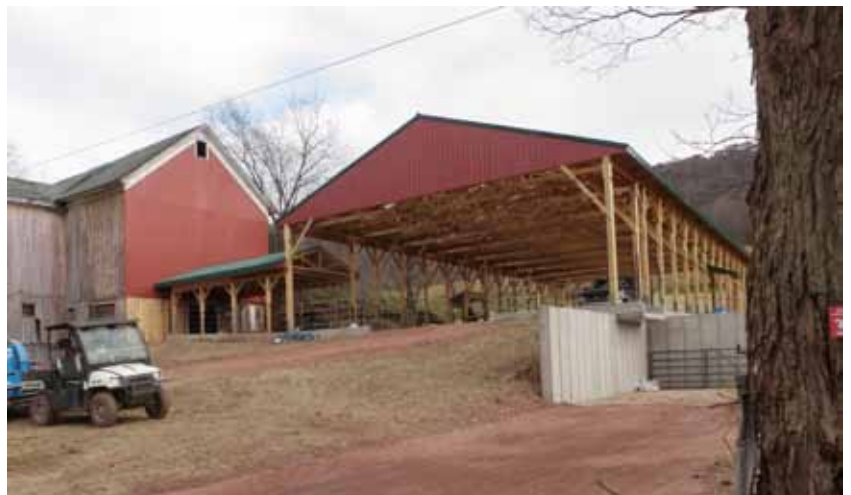
BOTTOM: Covered Feed Area with concrete push-off in foreground

Space constraints dictated where the Team located the covered structure. “Because of the barn’s orientation, we couldn’t tuck the covered facility in there any closer,” said O’Brien. “A breeze-way connects the existing barn to the new heifer area.” Just below the covered area is a push-off into a manure spreader parked on a concrete pad. Two short access roads connect the barn and the push-off; a third road exits the barnyard’s far end heading out to pasture. The Team also consulted with the State Department of Transportation to coordinate culverts and ditches along the County road farm.

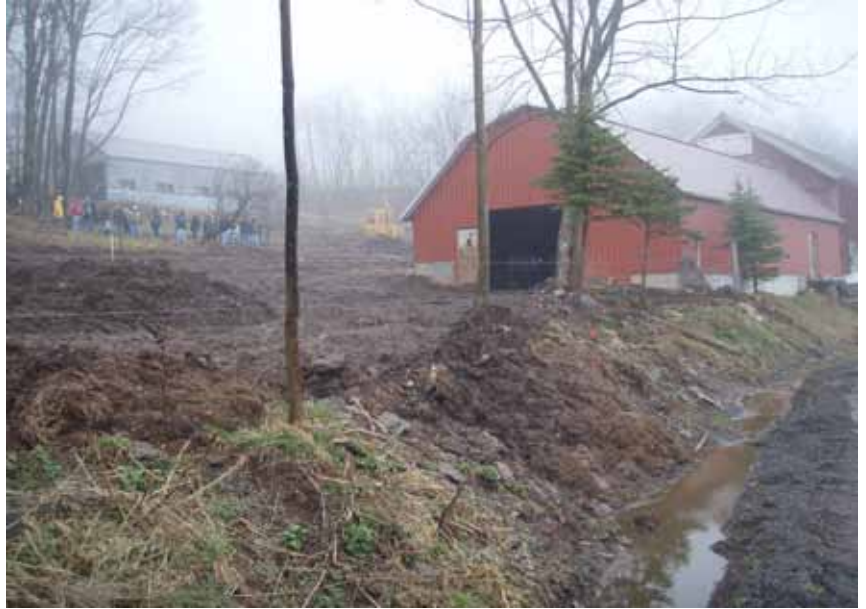
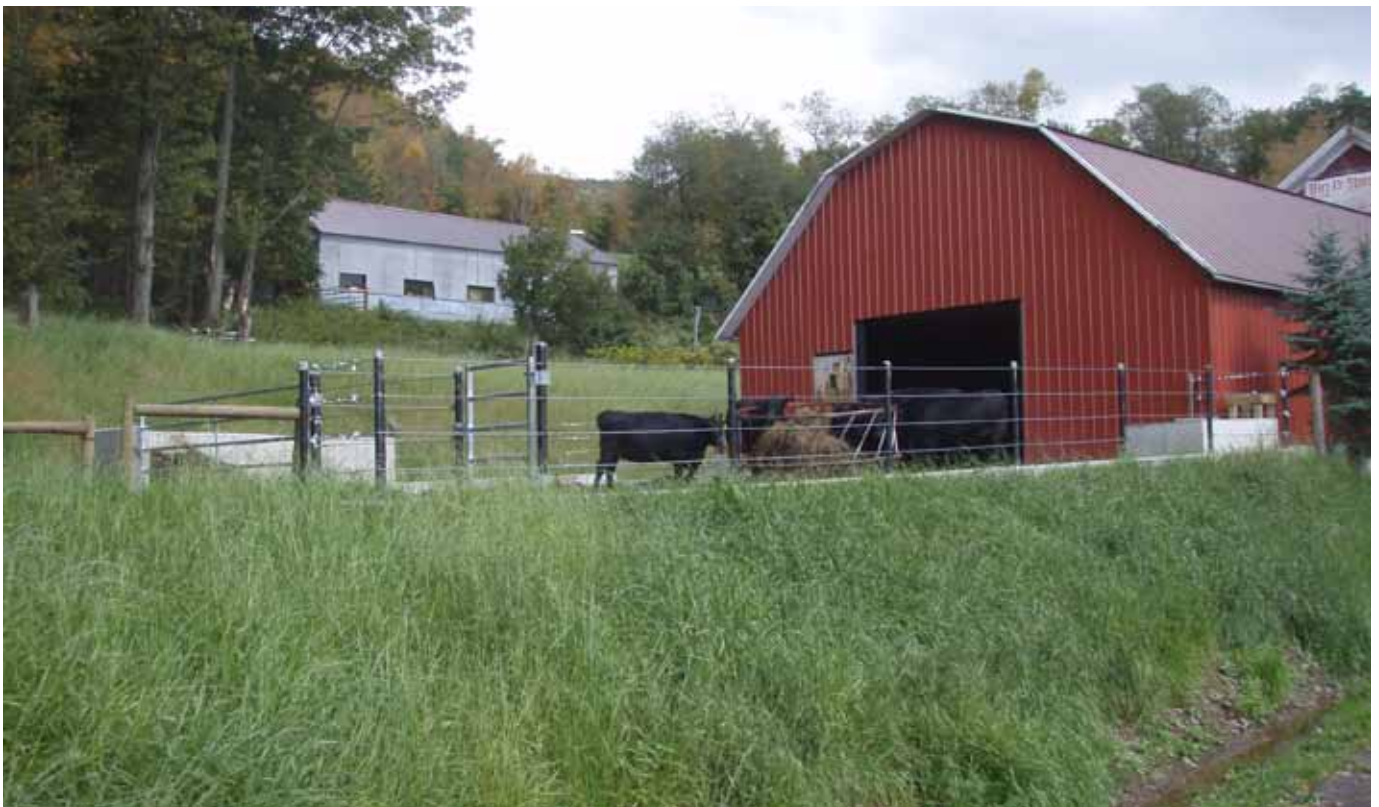
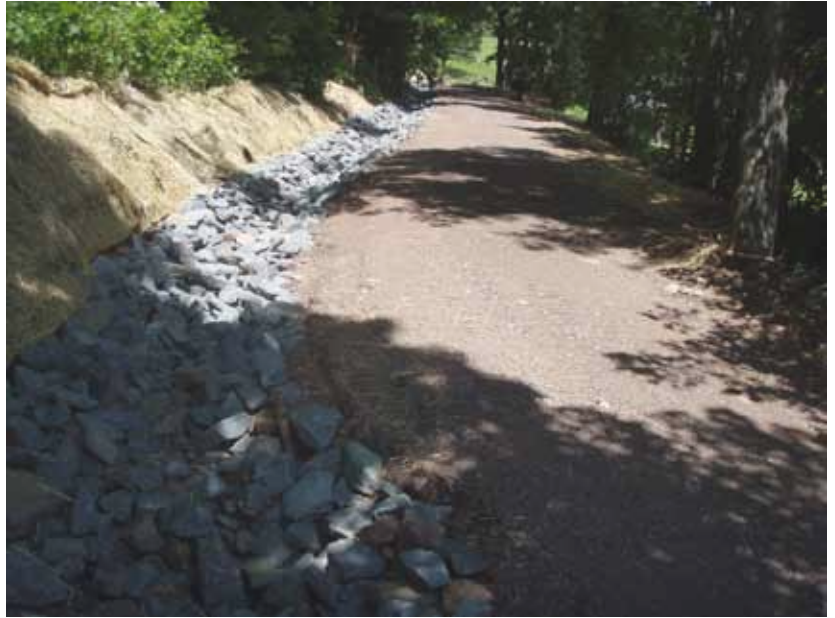
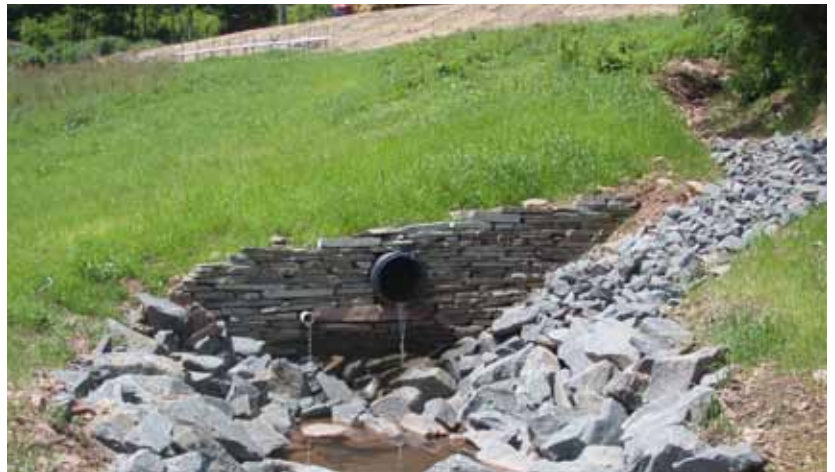
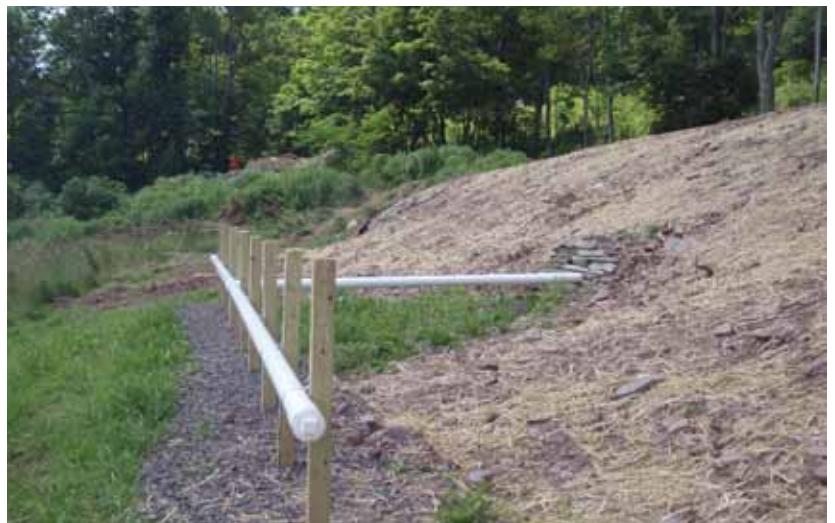
Stamford, Delaware County Concrete Barnyard, Heavy Use Area Pad, Drainage, Diversion, Watering Facility

At Guerrino and Maria Dianich's 300-acre farm in Stamford, Delaware County, the couple raises 30 beef cow-calf pairs. Water quality issues at the farm included water flowing downhill from a mountainside directly into the barnyard. Its momentum muddied up the outdoor feeding area, creating sedimentation and phosphorus issues within the watercourse below. "We had to address the project's location challenges," noted Dan Flaherty, Small Farms Coordinator for the Council. "Because of the barnyard's location, many acres drained directly into the winter feeding area. We were working with steep slopes and the barnyard was right up against the mountain. Question was, how do we best control water flow and slow it down in the process to reduce its impact?"

The Planning Team proposed a concrete barnyard, animal walkway, fencing, watering facility and a series of water control measures on the road's uphill side. On the downhill side, the Team designed a heavy use area pad (HUAP) for storing manure short term and a significant maze of drainage solutions. Construction contractor Sam Byler of Bainbridge oversaw the \$98,000 project including concrete, watering trough, fencing, and gravel. "He was very accommodating and a good listener,"

noted Flaherty. “When the landowner had concerns, Sam would do whatever it took to make it right.” In the 53’x57’ concrete barnyard, a corner buck wall serves as backstop for manure clean-up. From the barnyard, a 400-foot gravel walkway leads animals to pasture up the hill. Acting as a blanket, erosion-control rip-rap on the banks above a stone-lined ditch reduces sedimentation. To further diffuse runoff, the animal walkway consists of highly porous 1-inch-minus gravel over geotextile topped with compacted gravel to limit loose dirt from animal traffic.

“To address the influx of downhill clean water, we crafted a series of diversion and water control measures,” adds DCSWCD Civil Engineering Technician Chris Savage. “Clean hillside drainage now enters a diversion ditch uphill of the barnyard. Water is channeled through a series of plunge pools. This helps dissipate water speed and energy, again lessening the impact of fast waters and erosion, keeping clean water separate from the manure.”

The concrete barnyard’s dirty water now drains into a settling basin with three screens that further filter runoff. This first filtration step allows cleaner water to enter an underground settling tank where additional solids (or those that make it past the first screen set) are filtered out. The first tank settles out solids; a second tank stores water temporarily while the filter strip recharges. After a brief rest period, water from the flout tank enters an above-ground distribution pipe. This pipe diffuses runoff across the grassy filter area located across the road. Near the distribution pipe is a 30’x30’ gravel manure storage pad for temporary storage. The farmer spreads the manure every 2-3 months according to his Nutrient Management Plan.

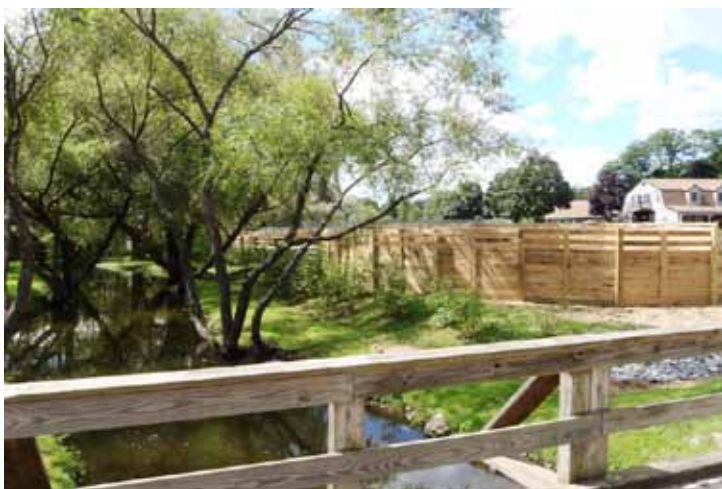
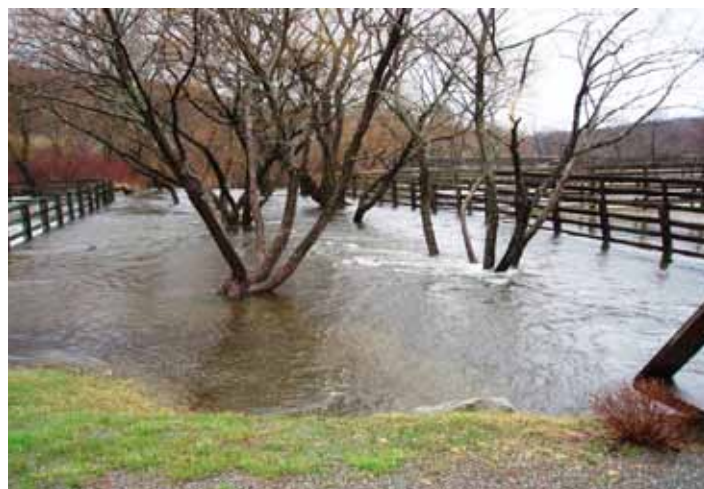
South Salem, Westchester County Heavy Use Area Protection Structure for Water Control Fencing

JT Farm is a horse boarding and training facility located within the Cross River drainage basin. Prior to implementation, the paddocks flooded often when the adjacent streams crested. As the stream receded, waste from inside the paddocks as well as footing material would often be transported downstream. BMPs installed at this project location included heavy use area protection and structure for water control. The paddocks adjacent to the stream were raised 3 feet in elevation to prevent the crested stream elevation from encroaching on the existing paddocks. In addition to the increase in elevation of the paddocks, a rip-rap lined channel was installed to collect water flowing over the existing access road. Also, 60 red osier dogwoods were planted on the side slopes of the stream bank for further stabilization.

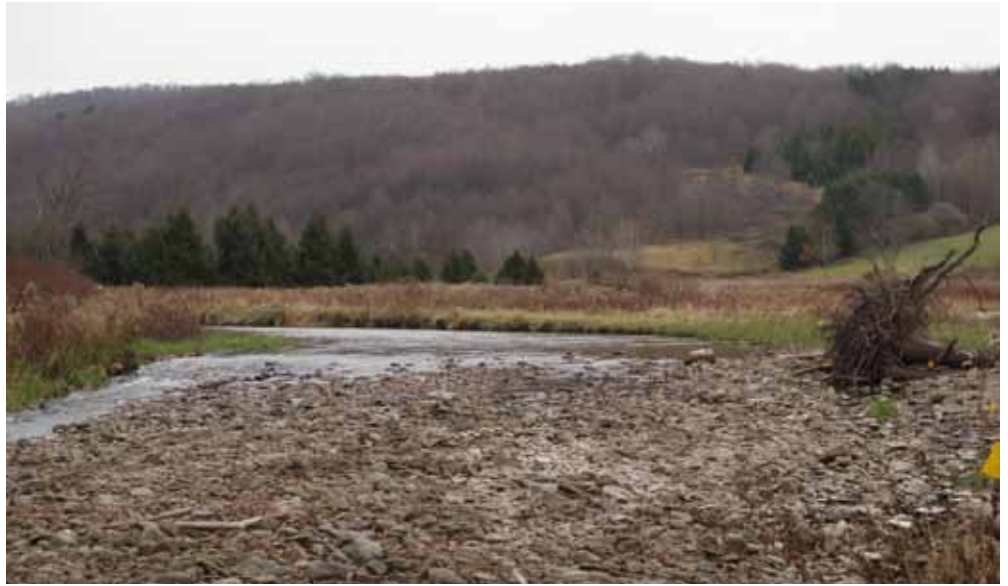
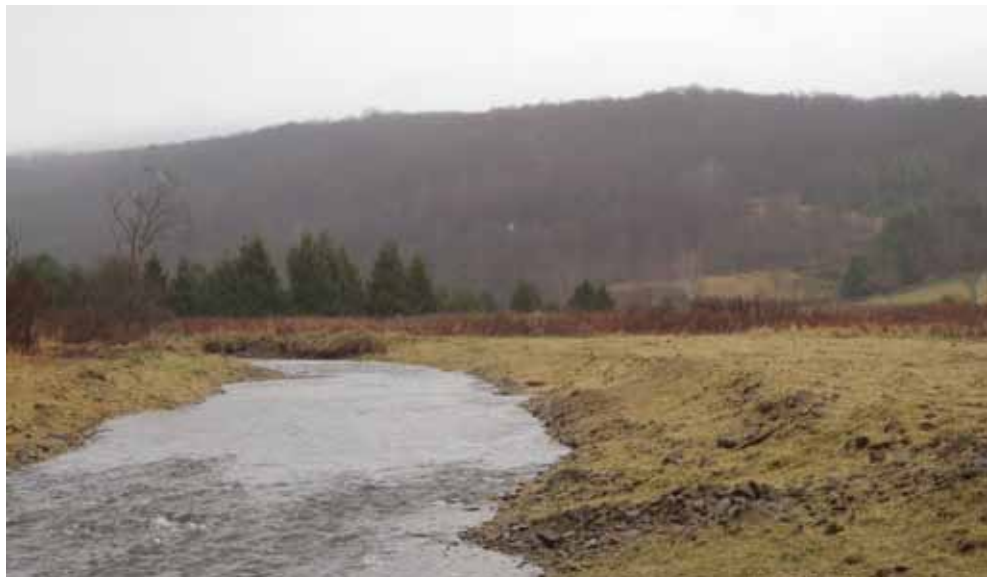
Walton, Delaware County Emergency Stream Restoration

Hurricane Irene left a sizable debris pile on the 12-acre mixed livestock farm of Todd and Lillian Burdick in August 2011. Horse, sheep, goats, pigs and poultry depend on the pastures for feed, forage and open space. Summer flooding deposited gravel throughout the streambed. As waters rose, the stream jumped its banks into adjacent pasture, rendering grass wet, unusable and inedible. High-velocity stream

waters carved a large gouge out of the pasture, further stripping away precious top soil, impacting the field's long-term usability, and hampering its pending enrollment into CREP (Conservation Reserve Enhancement Program). This farmer planned to enroll 35 feet from the top of the streambank into the pasture; and 840 feet running the length of the stream for a total of 1.5 acres enrolled.

The Planning Team had two priorities. First priority was to rechannel the water flow. Second, once the stream was restored to its original course, the reclaimed land area was to be enrolled in CREP. In November 2011, the Watershed Agricultural Program used \$5,000 from the Watershed Agricultural Council to redirect the stream to where it ran before the flood. The Planning Team surveyed the streambank with Delaware County Soil & Water District's Stream Team. Stream Technician Gale Neale instructed the Team on how to design rehabilitation project so water would be put back in its original channel. However, to fix any watershed stream requires a DEC Permit. NYS DEC liaison Steve Swenson worked with the Planning Team to obtain the needed permit quickly. He also outlined the steps needed to make the restoration process river-friendly such as dewatering prior to working in the stream. Bank berming was also forbidden as water needs access to flood plain. Don Tweedie excavated and bulldozed rock and earth out of the stream. He also insured the use of a temporary small berm to channel water away from the construction site. Once dewatering was in place, a bulldozer and excavator removed debris, pushing it to the side, regrading and re-seeding as they put the stream back to its natural course. After three days of work, the streambank was ready for rock stabilization and tree plantings in 2012 and for its CREP agreement.

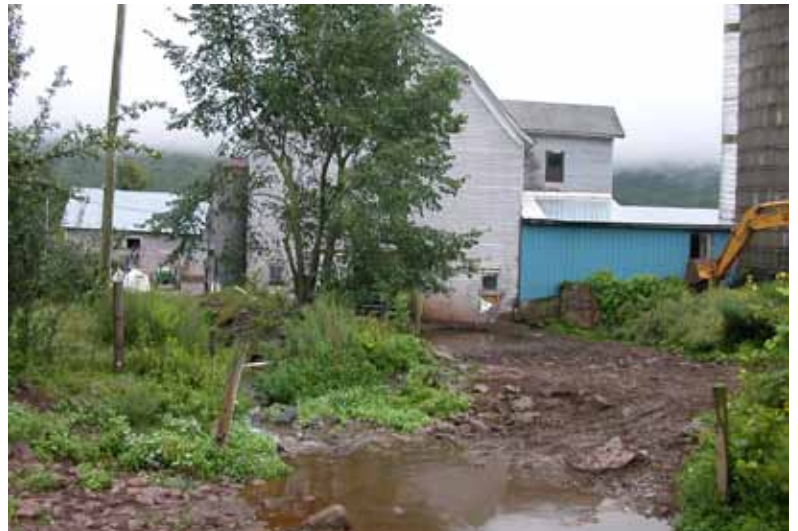
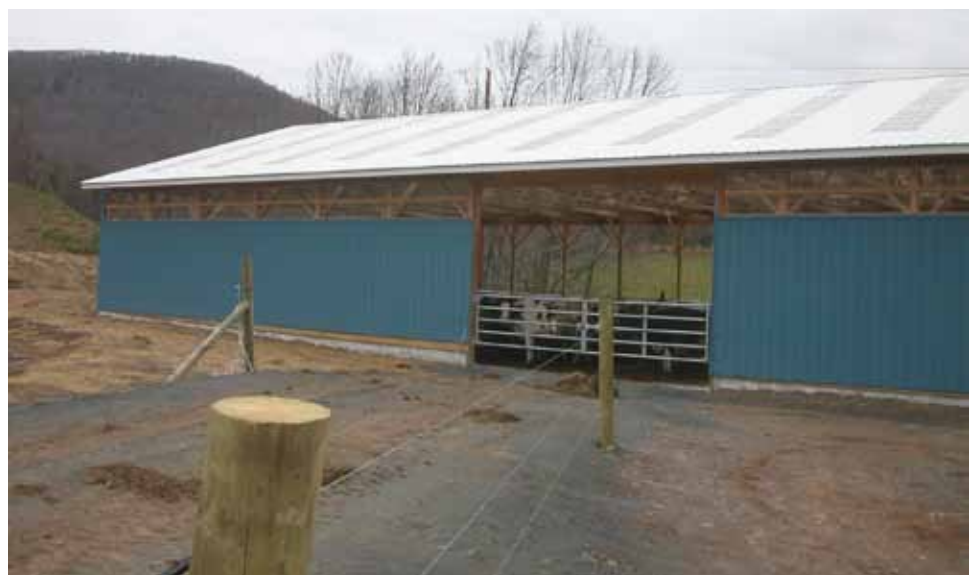
Roxbury, Delaware County Roofed Barnyard, Milkhouse Waste System, Silage Leachate Collection System, Animal Trail & Walkway

The 70-cow dairy VanValkenburg Farm presented water quality issues across the board. Nutrient runoff from the barnyard flowed directly into the stream seven feet away, with this small tributary off Johnson Hollow Brook draining into the Schoharie Reservoir. Milkhouse waste discharged into a dry well also located along the stream. Silage leachate trickled from the existing tower silo.

Construction included composite-laminated PermaColumns, tin roof and sun-sky panels to allow light into the 52-foot by 104-foot covered barnyard. Fourteen-foot-high trusses and a 19-foot by 16-foot long, 4-foot-high corner buckwall with a 10-foot high retaining wall permit large machinery entry for barnyard clean-up. A gravity-fed spring provides continuous winter water on the pad. Tin exterior walls block prevailing winds and reduce drifting snow. A 289-foot diversion ditch surrounding the foundation addresses drainage issues. The covered walkway runs 12 feet wide by 65 feet long from the existing dairy barn to the new barnyard. The barnyard is configured to allow a tractor and wagon

to drive onto and through the barnyard to unload corn silage to a tower silo. A concrete apron around the silo collects leachate and diverts it to a 2,000-gallon pre-cast, below-ground milkhouse waste tank away from the stream. A stream crossing to nightly pasture removes animals from the stream. Per the landowner’s request, the 400-foot walkway is stone dust instead of gravel for better hoof health, compacted surface and manageability.

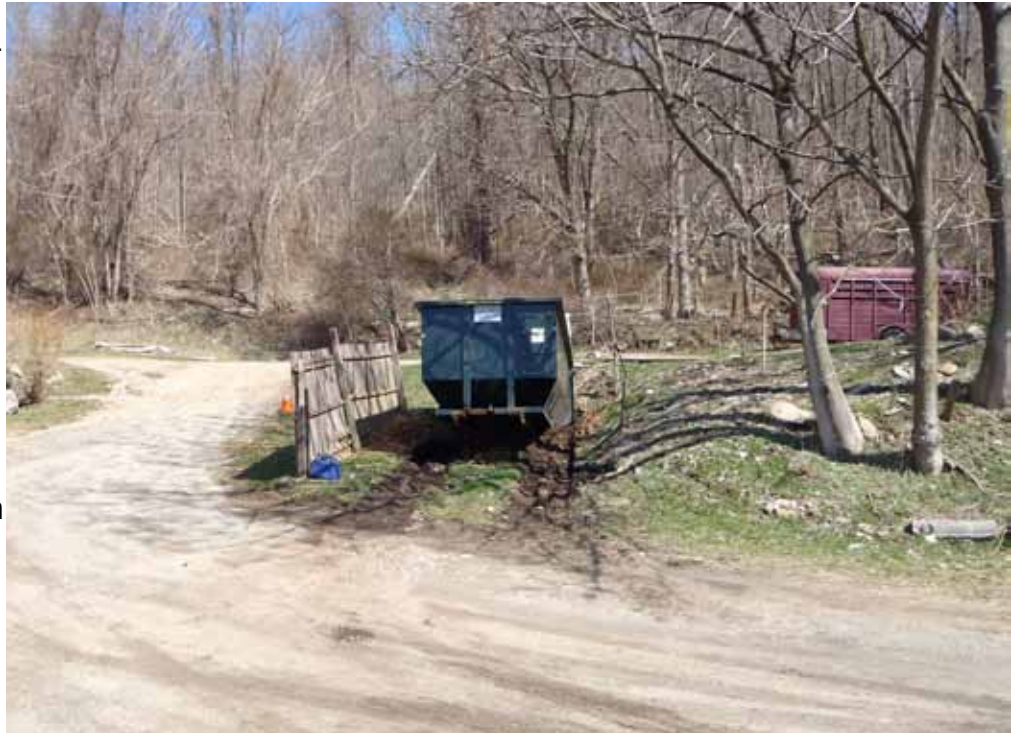
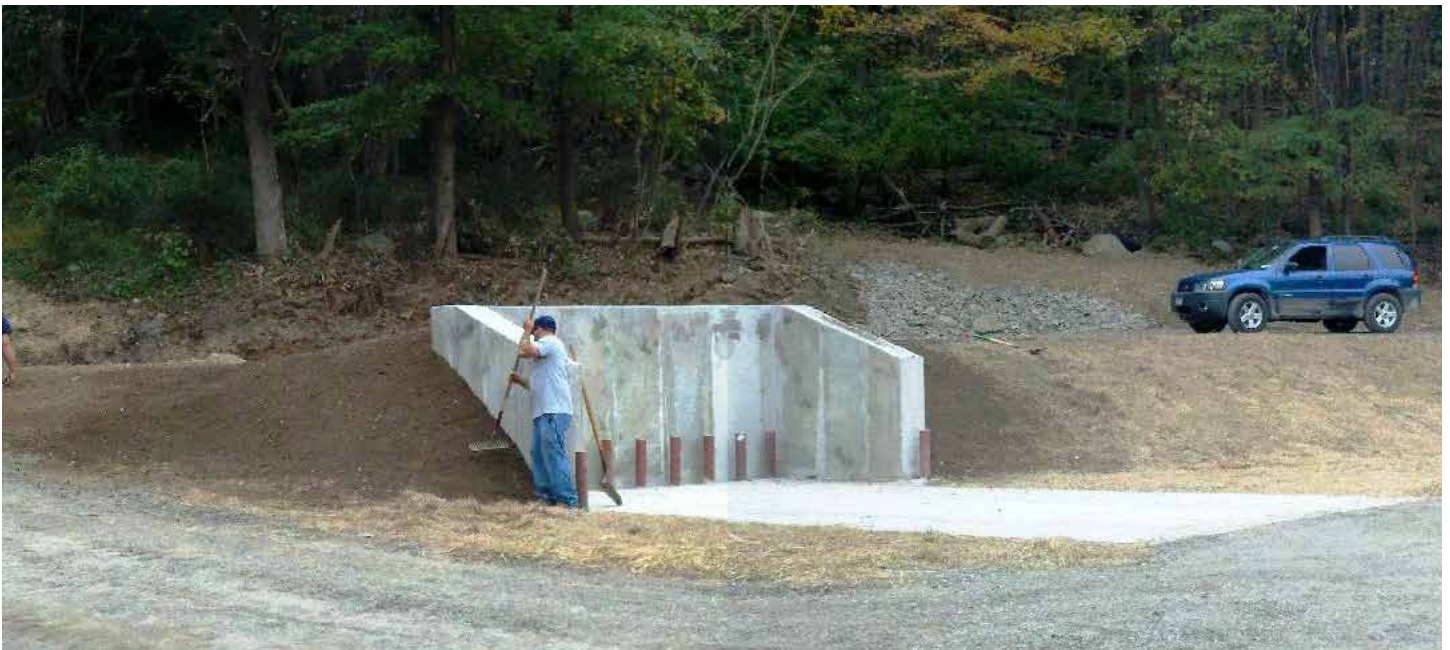
Purdys, Westchester County Heavy Use Area Protection, Diversion Vegetative Treatment Area

Purdys Farm leases the barns and property to a horse boarding operation located within the Muscoot Reservoir drainage basin. Prior to implementation, wastewater generated from the horse manure and bedding in the dumpster flowed over the existing access road and found its way to an existing stream offsite which flows into the Muscoot reservoir. In addition, a large drainage area contributed high volumes of stormwater flow transporting sediment and wastewater as it flowed over the existing paddocks. Implementation of BMPs included a heavy use area protection

(dumpster pad), vegetated treatment area, diversion channel and underground outlet for water control. The dumpster pad was pitched toward a vegetated treatment area adjacent to the pad that will serve to contain runoff and filter out pollutants. A diversion channel and outlet for water control was also installed to capture stormwater from a large drainage area and diverted away from the dumpster pad, vegetated treatment area, and paddocks. New gutters and downspouts were also installed on the existing barn to exclude clean water from potential areas of pollution. The BMPs implemented on this farm were successful in separating wastewater from stormwater thus preventing any wastewater runoff into the Muscoot Reservoir. Major gully erosion was occurring on this site.

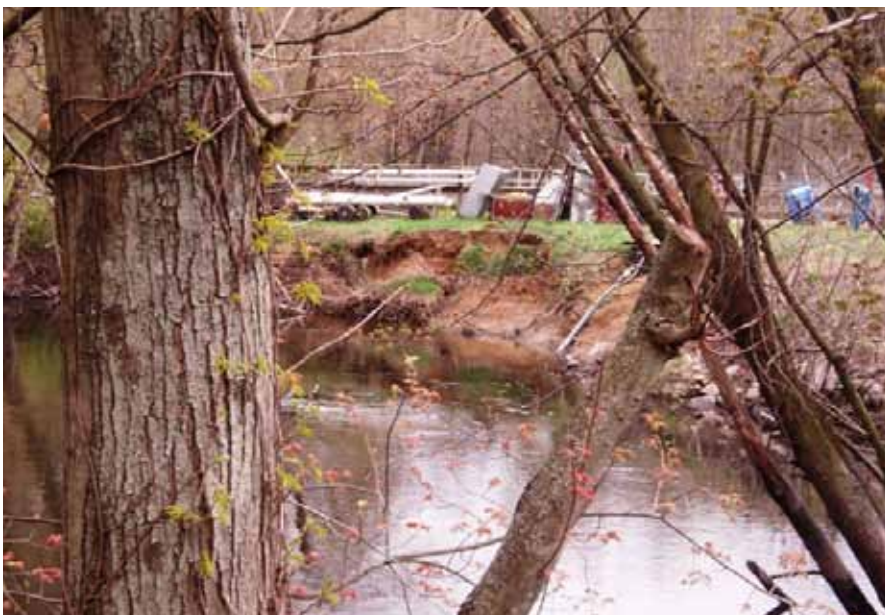
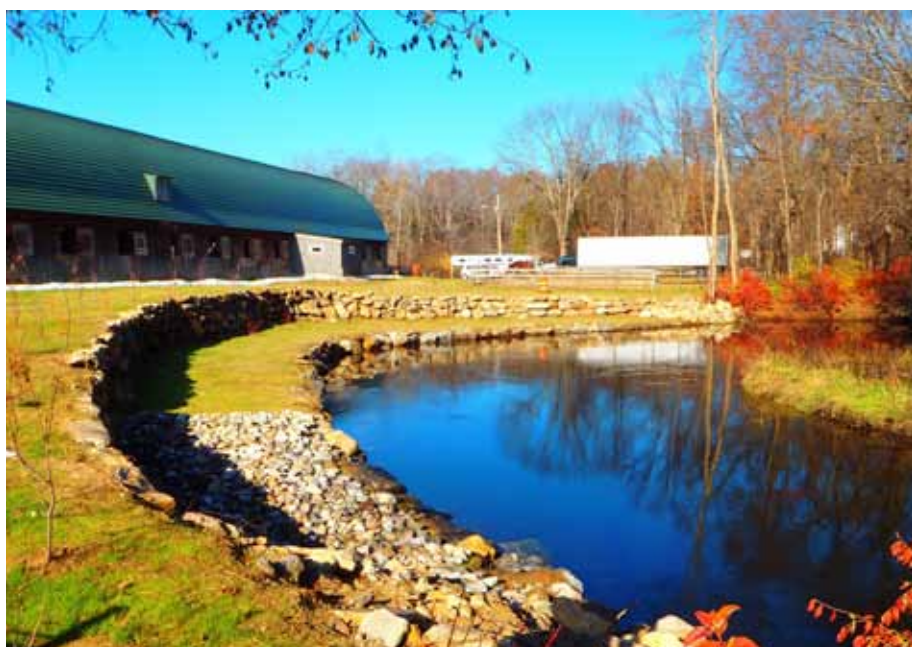
Brewster, Putnam County Streambank and Shoreline Protection

River Run farm is a horse boarding and training facility located in Brewster within the East Branch Reservoir drainage basin. The East Branch of the Croton River travels through this property with its nearest flow path 38 feet from the existing horse barn. Over time, this river has eroded the banks adjacent to the barn. To prevent further erosion and sloughing from occurring, streambank stabilization measures were installed at the banks of the river.

The streambank stabilization included the utilization of large 3-4 foot long oblong rocks from local sources. Larger rocks were used as keystones and were installed as a base for the remaining stones that were placed above the keystones. These rocks were utilized to build two sections of walls with each wall five feet high. A one-foot wide flood plain bench was installed for higher flow conditions. In addition to the rock stabilization, 60 red osier and flowering dogwoods were planted for further stabilization.
