Watershed Agricultural Program 2011 Annual Report and 2012 Workload

**for the New York City Catskill/Delaware and Croton Watersheds
February 2012**

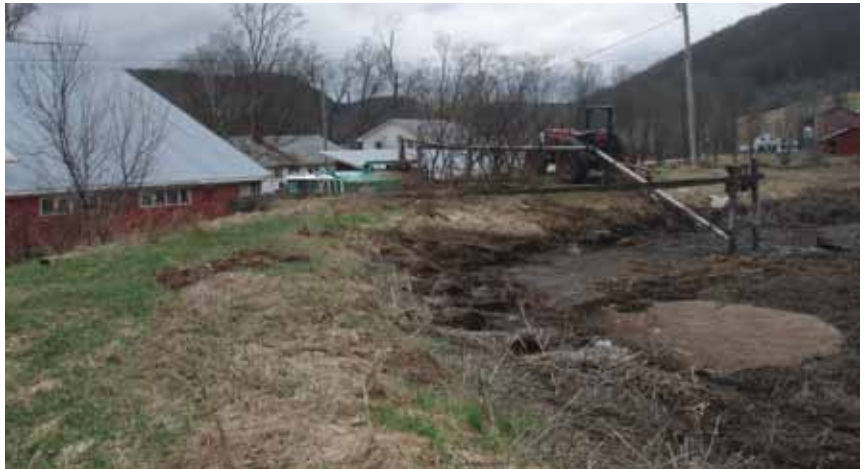
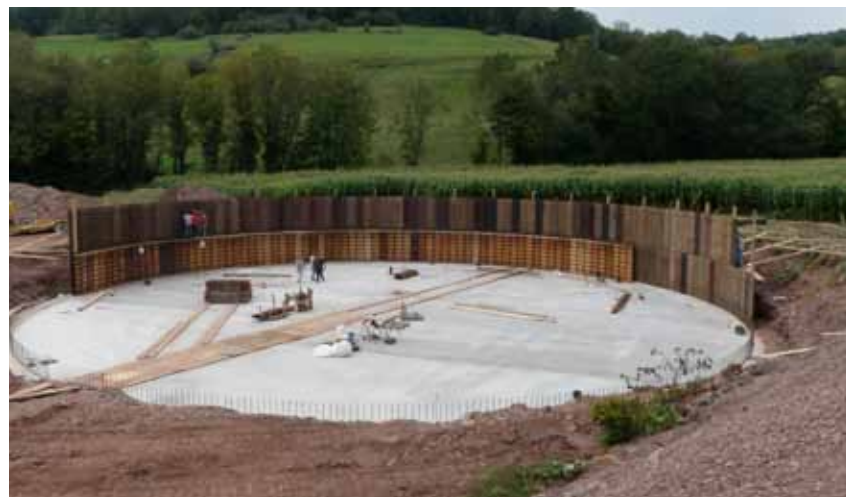
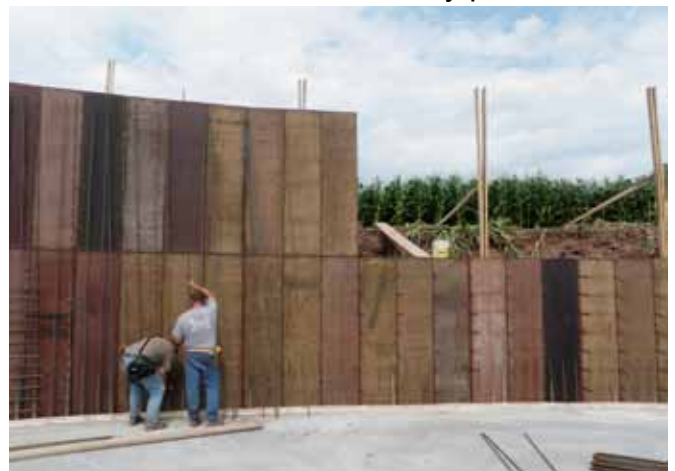
Delhi, Delaware County Manure Storage AWEP Funding

The Clark Farm milks 130 Holsteins and is located on Elk Creek Road in the town of Delhi NY, in the Cannonsville Watershed. The project's goal was to eliminate two earthen manure lagoons: one at the main milking facility and one at the heifer facility. Both lagoons had water infiltration issues; the new storages allow the producer to follow the farm's nutrient management plan to help limit the run-off possibilities. Three challenges arose at the project site. First, the project site was divided by Dry Brook. Second, the distance separating the two barns made it cost-prohibitive to install one storage used by both facilities. Third, a high water table, due to the proximity to Dry Brook, posed fluctuating water variables. The Planning Team recommended constructing two cast-in-place, in-ground

concrete storages. The main barn storage is 120 feet across in diameter and 16 feet deep, capable of storing 1.3 million gallons. The heifer barn storage is 60 feet across by 16 feet deep and can hold 338,000 gallons. The project also required a new manure pump system to handle the manure at the main barn. The Team accomplished this by changing an existing gutter-style barn cleaner to a gravity-gutter that feeds the new hydraulic-style piston pump that pumps to the 120-foot storage. A stand-alone pump building was set up so the pump could

be in a central location for the gravity gutter, and not interfere with current farm access. The milkhouse waste along with the parlor waste is now pumped to storage. Manure at the heifer facility is now scraped directly into the 60-foot storage which is located off the end of the barn. A newly purchased lagoon-style agitation pump facilitates agitation and manure removal from the new storage tanks. Once the new storage tanks were constructed and operational, the old earthen lagoons were decommissioned. The heifer facility lagoon was decommissioned by having the dams removed and leveled out to match existing ground. The main barn lagoon was decommissioned using a combination of dam removal and fill dirt to match grades around the former lagoon site. LaFever Excavation was the General contractor for the project and sub-contracted Ben Reynolds Construction for the concrete work. The project cost \$598,288.

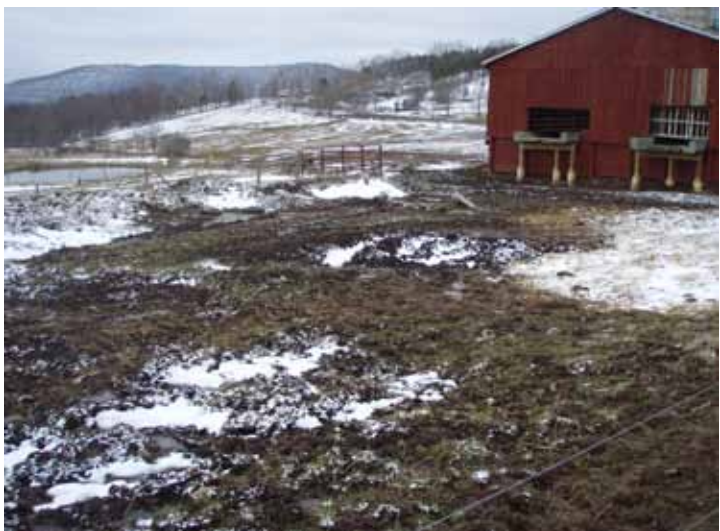
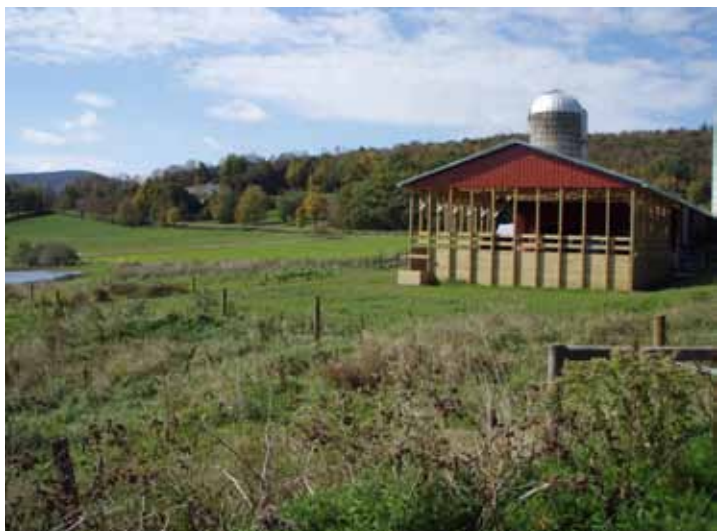
Stamford, Delaware County

At this 140-acre beef farm in Stamford, Delaware County, farmer John Trovato raises 30 cows, grows garlic and tends bees. During the spring and summer, the herd grazes on pasture according to a rotational grazing plan created by WAC Small Farms Coordinator Dan Flaherty. In winter, the farmer brings the herd closer to the barn which posed a feeding area problem. The water quality issue was simple: address the winter feeding area adjacent to stream just eight feet away.

Many water seeps and drainage issues around the barn had to be addressed during the first part of construction. Those identified were laid with cobbles; buried perforated pipes directed drainage into the Conservation Reserve Enhancement Program (CREP) area. An underground drip trench lined with PVC pipe and gravel also surrounded the barnyard to allow roof water to flow into the CREP area behind the barn. The Plan called for a CREP riparian forest buffer. Last year, roughly eight acres and necessary fencing were installed to keep animals out of the stream. This year, additional fencing connected with the CREP fencing, thus protecting a hydrologically sensitive area.

Construction was neat and simple. Sun-sky panels dotted the tin roof. Laminated poles, comprised of three-treated-then-glued-together 2x6s, supported the 40-foot by 60-foot structure. These new laminated poles offer better strength and protection from rot than standard 6x6 posts. Built off the existing barn, the new construction allowed farmer access to two existing manure push-offs that he wanted to utilize. "The water trough tapped into an existing spring development we installed in 2010," added Flaherty. "The gravity-fed, continuous flow set-up provided year-round watering to the feeding/manure storage area." As part of the overall Whole Farm Plan, the Council also purchased a bucket loader for the farmer's tractor to help with barnyard clean-up. "Thanks to the farmer and his farm manager, we trouble-shooted the issues and breezed through this project in record time," added Flaherty.

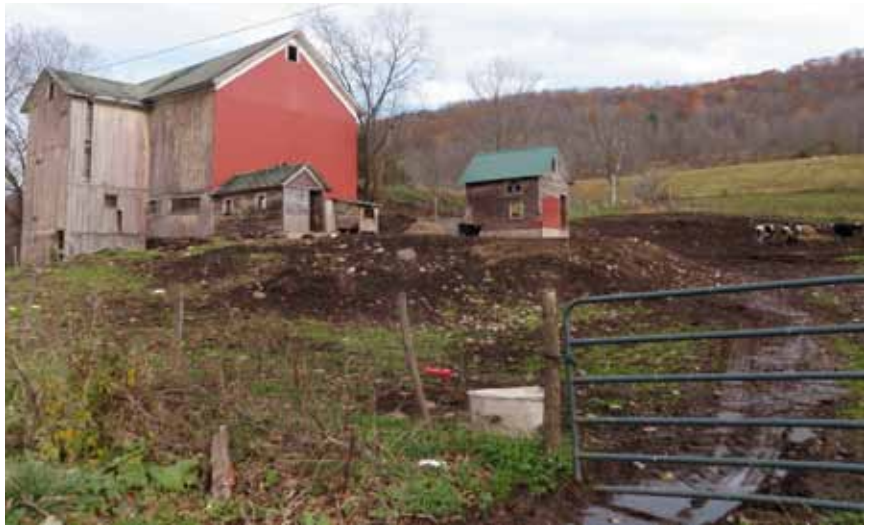
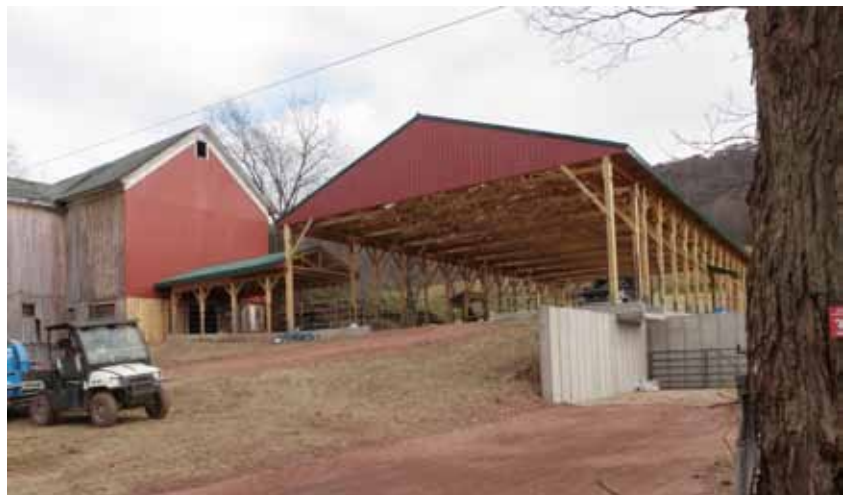
Kortright, Delaware County Covered Barnyard

TOP: Youngstock area with drainage issues

BOTTOM: Covered Feed Area with concrete push-off in foreground

The youngstock building accommodates two different aged animals. Through a gated system, the farmer can corral older heifers in the open, covered feeding area and gate off younger animals in a separate, safer area. Normally, the farmer used an I-beam feeding trough along the outside of the building. The new structure, with feed dispersed down the center, allows the two groups to be separate but eat from the same pile. This center feed alley posed a new challenge for the farmer to relearn how to navigate the Bobcat in order to clear away the feed area. “By making the feed area wide enough for a skid steer turning radius, we now have an issue for the cow reaching out for feed, something we’ll troubleshoot going forward” added O’Brien. Two watering facilities, one on each side for the separated animals, provide water from an original gravity system installed 8 years prior. “With no electricity out to the heifer barnyard, we chose continuous overflow, gravity system as we had no ability to heat the water,” added O’Brien.

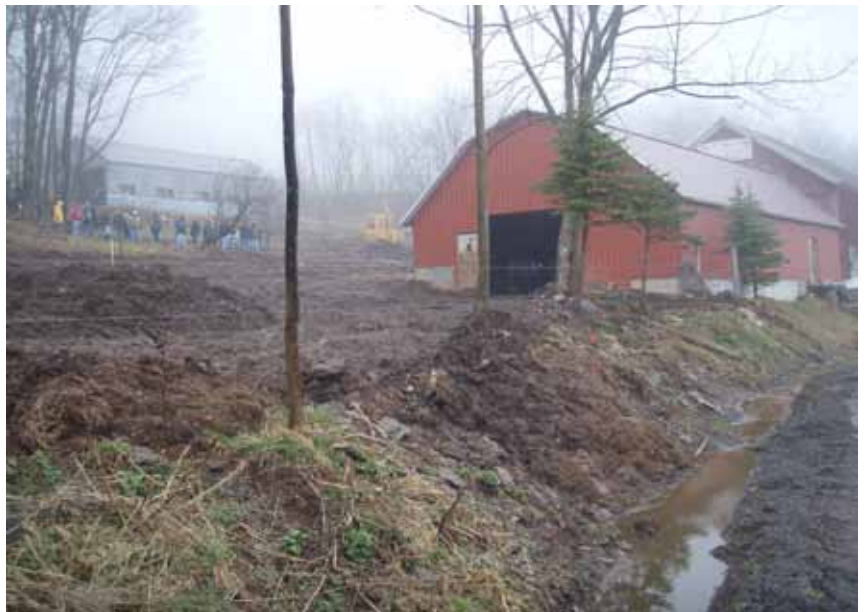
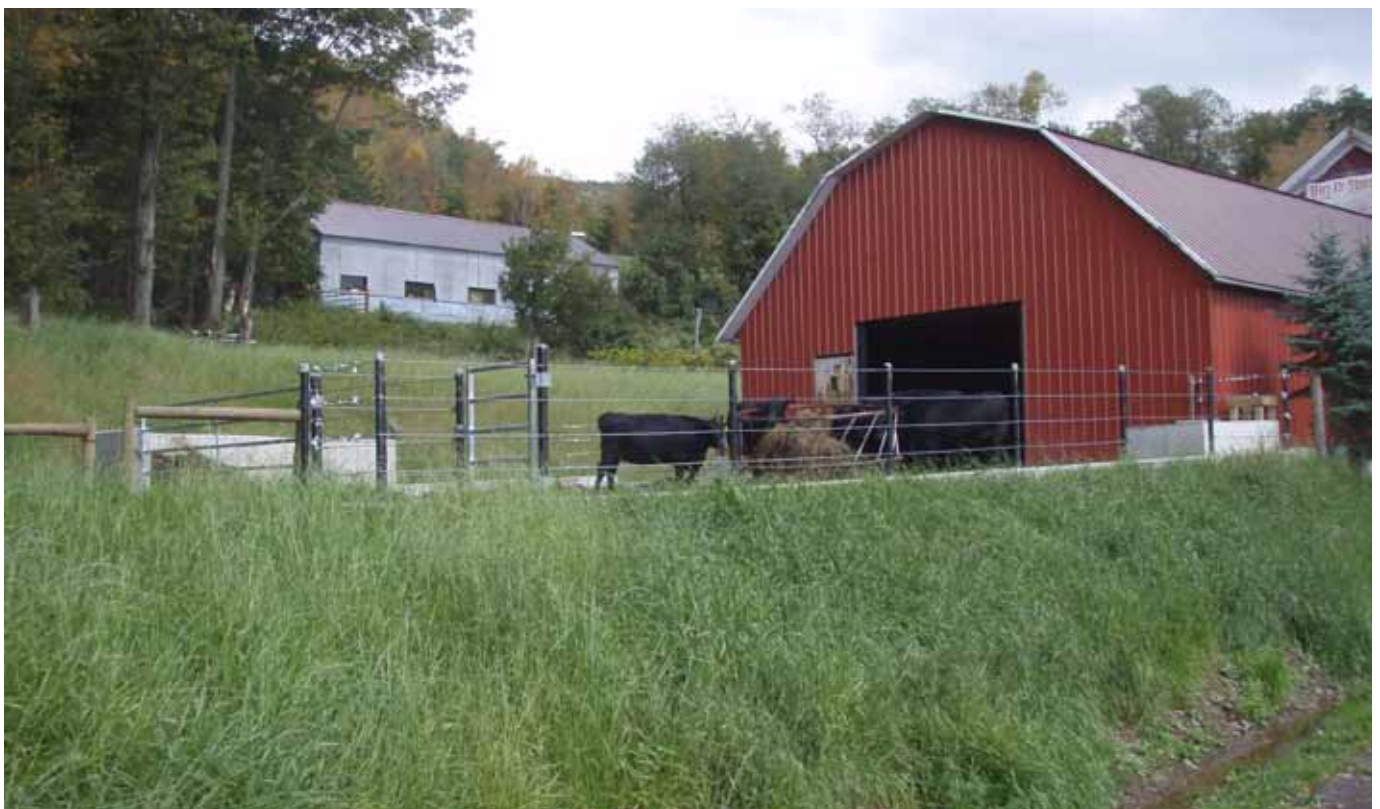
Stamford, Delaware County Concrete Barnyard, Heavy Use Area Pad, Drainage, Diversion, Watering Facility

The Planning Team proposed a concrete barnyard, animal walkway, fencing, watering facility and a series of water control measures on the road's uphill side. On the downhill side, the Team designed a heavy use area pad (HUAP) for storing manure short term and a significant maze of drainage solutions. Construction contractor Sam Byler of Bainbridge oversaw the \$98,000 project including concrete, watering trough, fencing, and gravel. "He was very accommodating and a good listener,"

noted Flaherty. “When the landowner had concerns, Sam would do whatever it took to make it right.” In the 53’x57’ concrete barnyard, a corner buck wall serves as backstop for manure clean-up. From the barnyard, a 400-foot gravel walkway leads animals to pasture up the hill. Acting as a blanket, erosion-control rip-rap on the banks above a stone-lined ditch reduces sedimentation. To further diffuse runoff, the animal walkway consists of highly porous 1-inch-minus gravel over geotextile topped with compacted gravel to limit loose dirt from animal traffic.

“To address the influx of downhill clean water, we crafted a series of diversion and water control measures,” adds DCSWCD Civil Engineering Technician Chris Savage. “Clean hillside drainage now enters a diversion ditch uphill of the barnyard. Water is channeled through a series of plunge pools. This helps dissipate water speed and energy, again lessening the impact of fast waters and erosion, keeping clean water separate from the manure.”

The concrete barnyard’s dirty water now drains into a settling basin with three screens that further filter runoff. This first filtration step allows cleaner water to enter an underground settling tank where additional solids (or those that make it past the first screen set) are filtered out. The first tank settles out solids; a second tank stores water temporarily while the filter strip recharges. After a brief rest period, water from the flout tank enters an above-ground distribution pipe. This pipe diffuses runoff across the grassy filter area located across the road. Near the distribution pipe is a 30’x30’ gravel manure storage pad for temporary storage. The farmer spreads the manure every 2-3 months according to his Nutrient Management Plan.

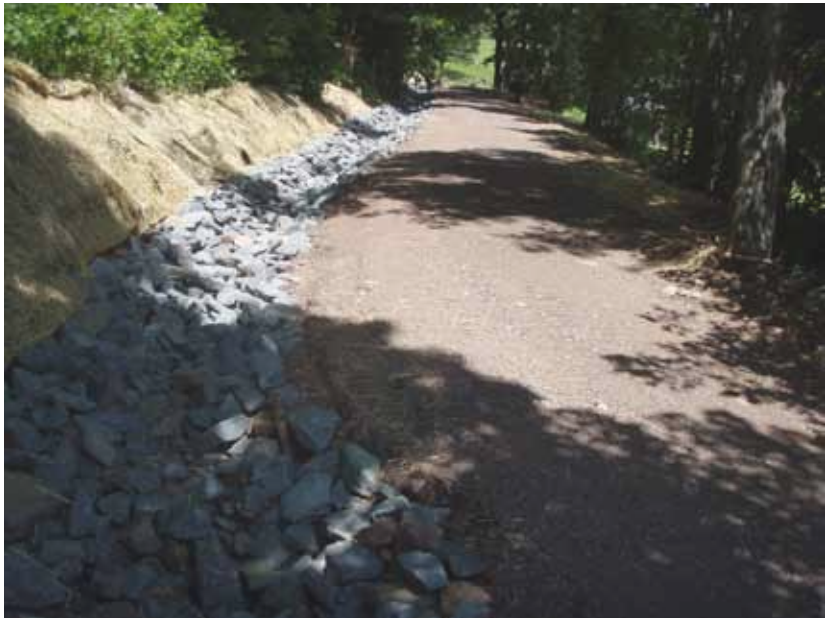
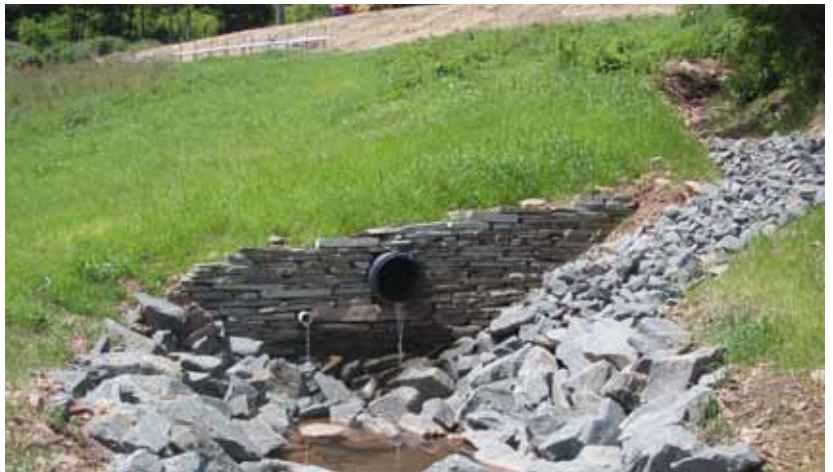
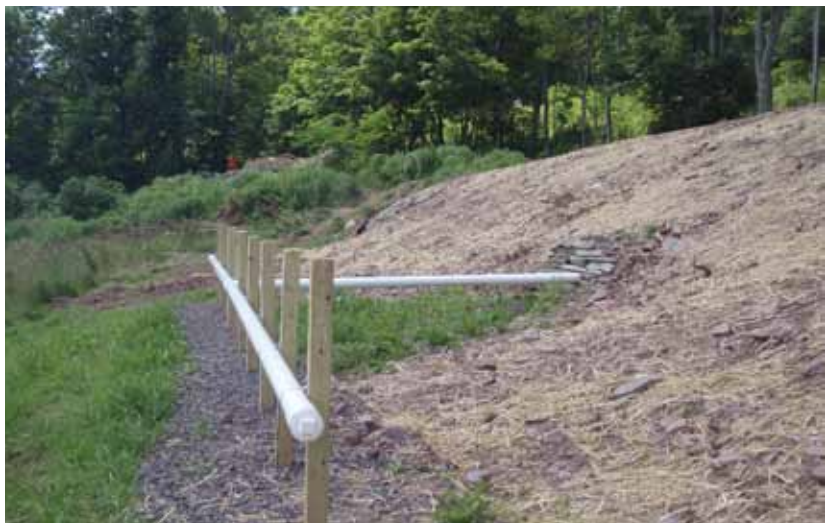
South Salem, Westchester County

JT Farm is a horse boarding and training facility located within the Cross River drainage basin. Prior to implementation, the paddocks flooded often when the adjacent streams crested. As the stream receded, waste from inside the paddocks as well as footing material would often be transported downstream. BMPs installed at this project location included heavy use area protection and structure for water control. The paddocks adjacent to the stream were raised 3 feet in elevation to prevent the crested stream elevation from encroaching on the existing paddocks. In addition to the increase in elevation of the paddocks, a rip-rap lined channel was installed to collect water flowing over the existing access road. Also, 60 red osier dogwoods were planted on the side slopes of the stream bank for further stabilization.

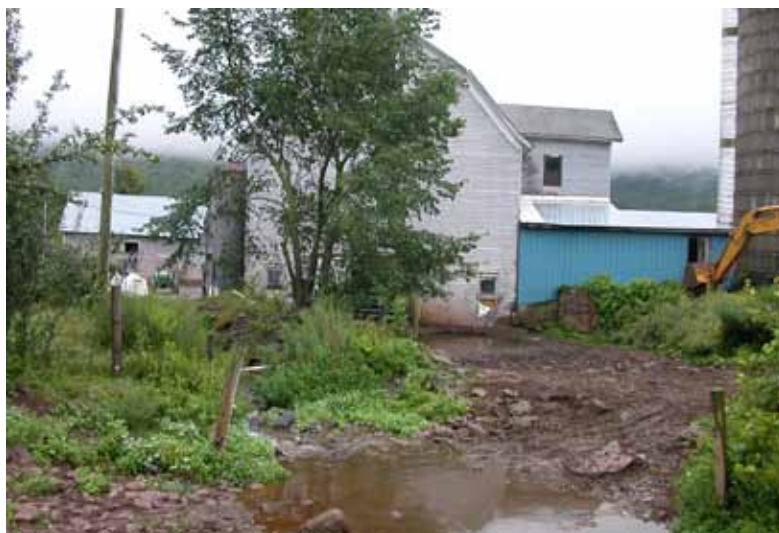
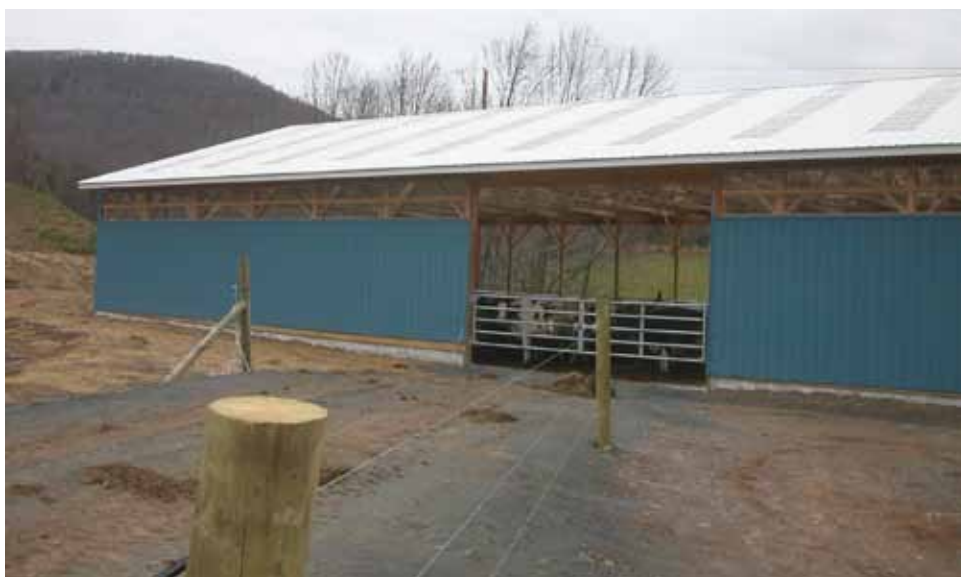
Roxbury, Delaware County Roofed Barnyard, Milkhouse Waste System, Silage Leachate Collection System, Animal Trail & Walkway

The 70-cow dairy VanValkenburg Farm presented water quality issues across the board. Nutrient runoff from the barnyard flowed directly into the stream seven feet away, with this small tributary off Johnson Hollow Brook draining into the Schoharie Reservoir. Milkhouse waste discharged into a dry well also located along the stream. Silage leachate trickled from the existing tower silo.

Construction included composite-laminated PermaColumns, tin roof and sun-sky panels to allow light into the 52-foot by 104-foot covered barnyard. Fourteen-foot-high trusses and a 19-foot by 16-foot long, 4-foot-high corner buckwall with a 10-foot high retaining wall permit large machinery entry for barnyard clean-up. A gravity-fed spring provides continuous winter water on the pad. Tin exterior walls block prevailing winds and reduce drifting snow. A 289-foot diversion ditch surrounding the foundation addresses drainage issues. The covered walkway runs 12 feet wide by 65 feet long from the existing dairy barn to the new barnyard. The barnyard is configured to allow a tractor and wagon to drive onto and through the barnyard to unload corn silage to a tower silo. A concrete apron around the silo collects leachate and diverts it to a 2,000-gallon pre-cast, below-ground milkhouse waste tank away from the stream. A stream crossing to nightly pasture removes animals from the stream. Per the landowner’s request, the 400-foot walkway is stone dust instead of gravel for better hoof health, compacted surface and manageability.

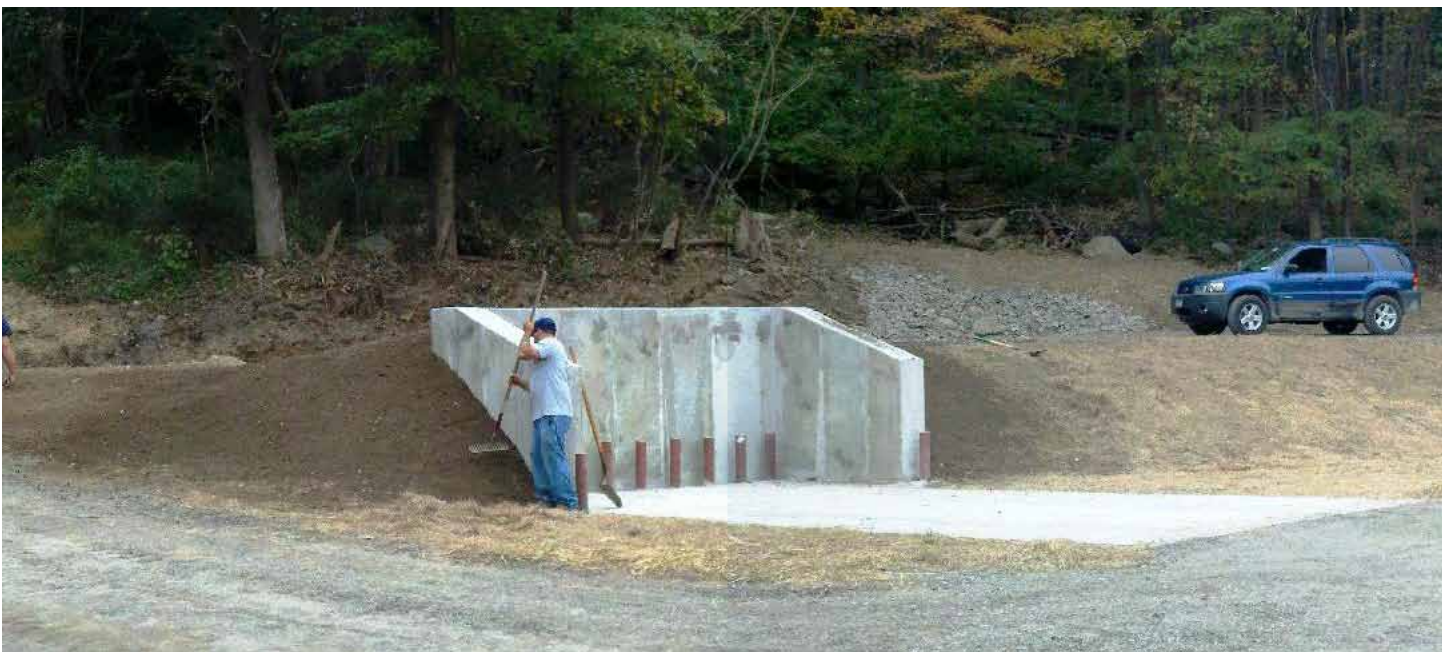
Purdys, Westchester County Heavy Use Area Protection, Diversion Vegetative Treatment Area

Purdys Farm leases the barns and property to a horse boarding operation located within the Muscoot Reservoir drainage basin. Prior to implementation, wastewater generated from the horse manure and bedding in the dumpster flowed over the existing access road and found its way to an existing stream offsite which flows into the Muscoot reservoir. In addition, a large drainage area contributed high volumes of stormwater flow transporting sediment and wastewater as it flowed over the existing paddocks. Implementation of BMPs included a heavy use area protection

(dumpster pad), vegetated treatment area, diversion channel and underground outlet for water control. The dumpster pad was pitched toward a vegetated treatment area adjacent to the pad that will serve to contain runoff and filter out pollutants. A diversion channel and outlet for water control was also installed to capture stormwater from a large drainage area and diverted away from the dumpster pad, vegetated treatment area, and paddocks. New gutters and downspouts were also installed on the existing barn to exclude clean water from potential areas of pollution. The BMPs implemented on this farm were successful in separating wastewater from stormwater thus preventing any wastewater runoff into the Muscoot Reservoir. Major gully erosion was occurring on this site.

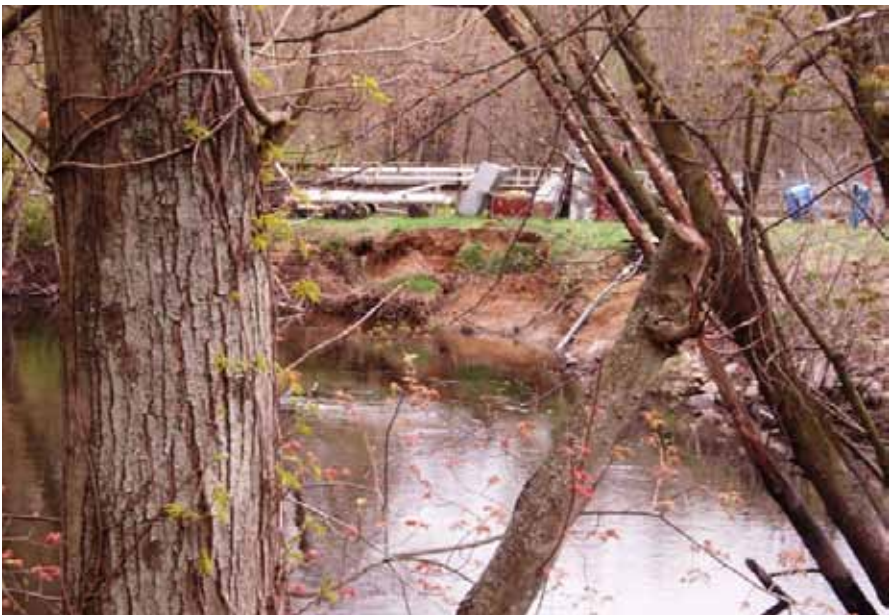
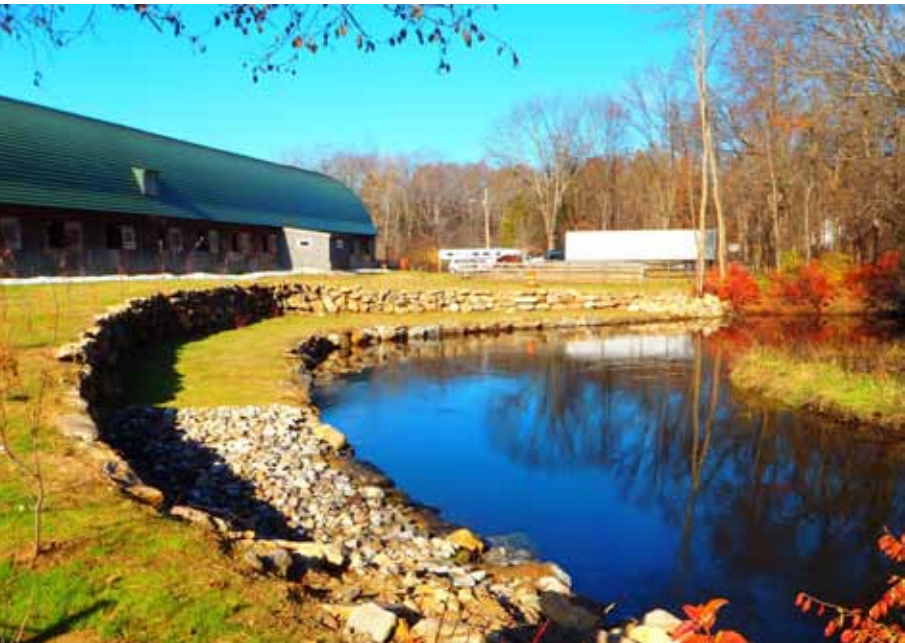
Brewster, Putnam County Streambank and Shoreline Protection

River Run farm is a horse boarding and training facility located in Brewster within the East Branch Reservoir drainage basin. The East Branch of the Croton River travels through this property with its nearest flow path 38 feet from the existing horse barn. Over time, this river has eroded the banks adjacent to the barn. To prevent further erosion and sloughing from occurring, streambank stabilization measures were installed at the banks of the river.

The streambank stabilization included the utilization of large 3-4 foot long oblong rocks from local sources. Larger rocks were used as keystones and were installed as a base for the remaining stones that were placed above the keystones. These rocks were utilized to build two sections of walls with each wall five feet high. A one-foot wide flood plain bench was installed for higher flow conditions. In addition to the rock stabilization, 60 red osier and flowering dogwoods were planted for further stabilization.
